HOLE-TYPE NOZZLES
WITH RESTRICTED
SPRAY ORIFICES

Workshop: EP
02.1992
0311 En

Robert Bosch GmbH
Division KH
After-Sales-Service Department for
Training and Technology (KH/VSK)

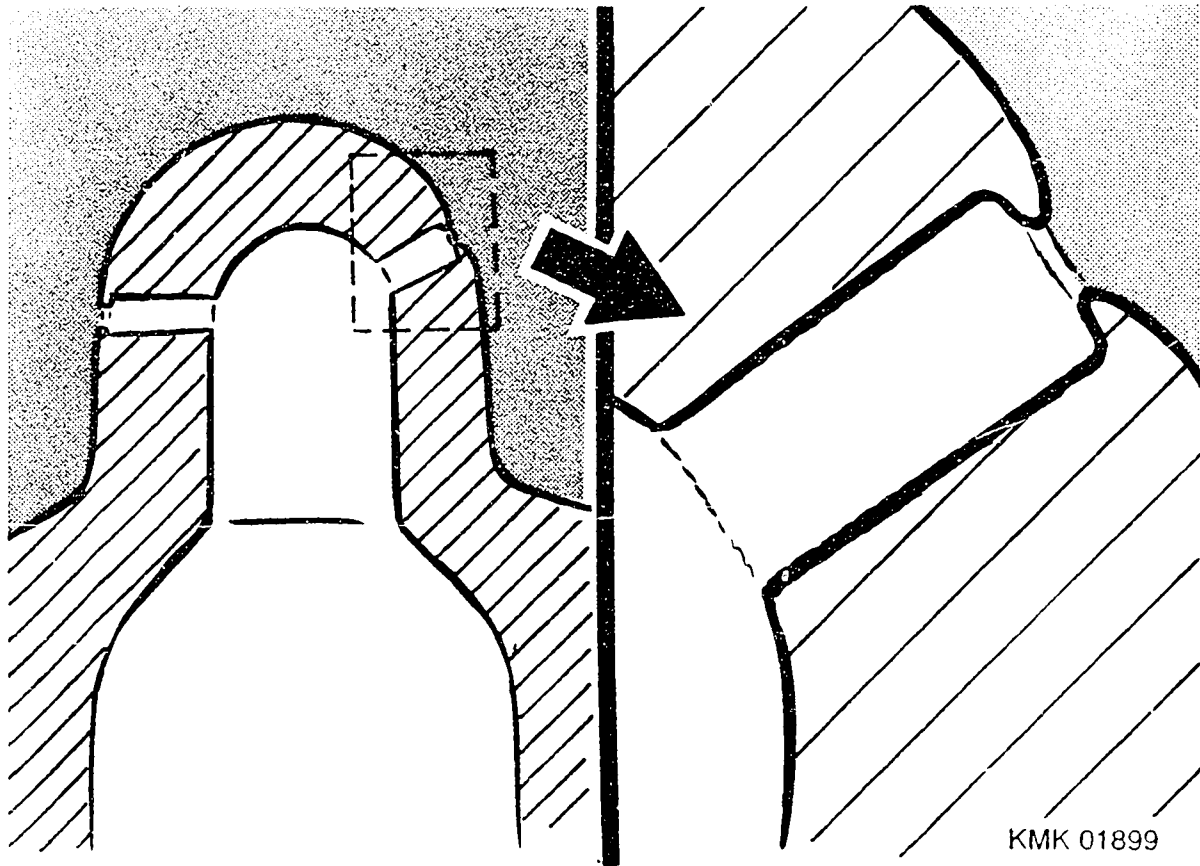
KMK 01899

Characteristic features are rounding of the edge of the spray orifice and - depending on the size of the restriction - a bead-like constriction in the spray orifice.

Enlargement of restricted spray orifice.

The edges of the spray orifices are normally sharp (even on used nozzles). Nozzles with restricted spray orifices are always to be scrapped and replaced with new ones.

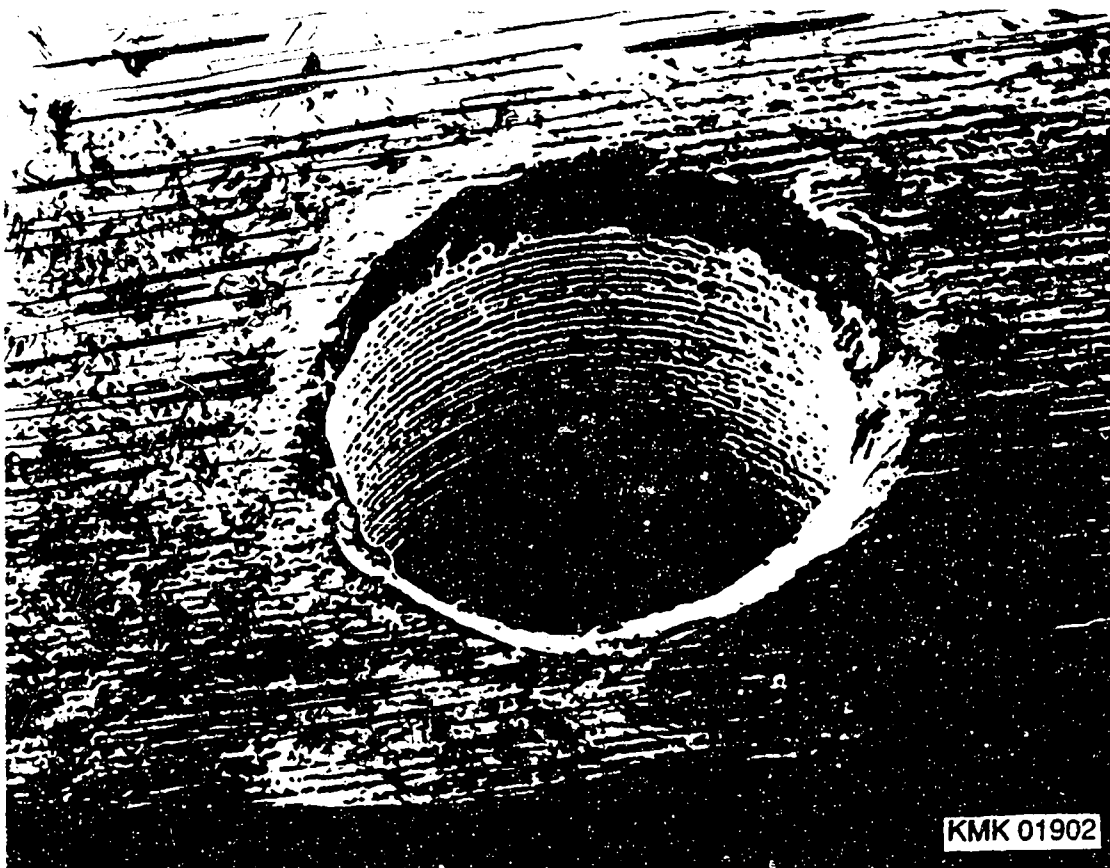
Restricted spray orifice edge.
Reduction in flow approx. 5 %.

The spray orifice edge is no longer sharp, but rather clearly rounded.

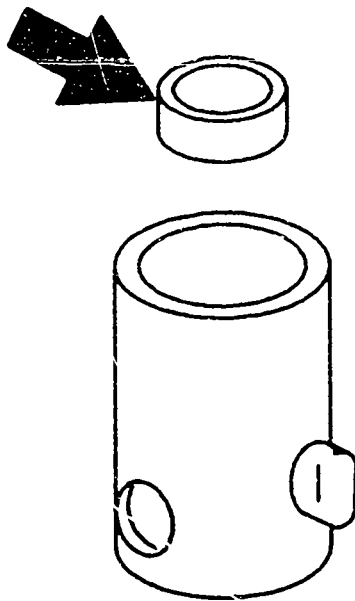
KMK02600

If it becomes necessary to replace roller tappet assembly 2 418 750 022 because of a broken pressure plate (see illustration), you must replace all 6 with part numbers 2 418 750 041. After doing so, we remind you to check plunger LPC and phasing.

Arrow = Pressure Plate

The exchange of the roller tappet assemblies is to be performed only in the event of breakage.
Standard warranty terms apply.

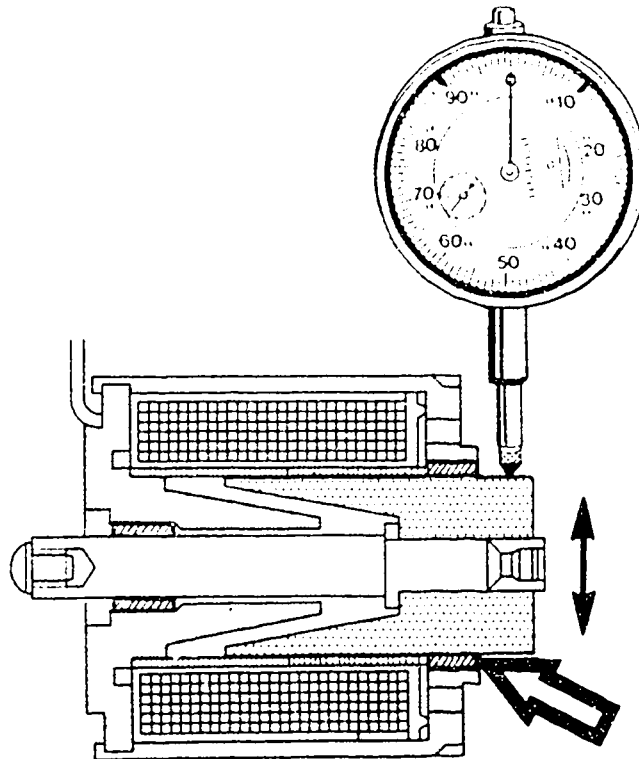
KMK 03078

The problem is usually caused by a stiff electromagnet armature in the adjusting magnet of the RE positioner due to one-sided wear of the large electromagnet-armature bushing (picture, arrow).

Such wear cannot be detected during normal testing of the IP assembly on an IP test bench. For this reason, should such complaints be received, the adjusting magnet is to be removed and the bearing wear measured.

The max. bearing clearance for the large bushing is 0.12 mm.

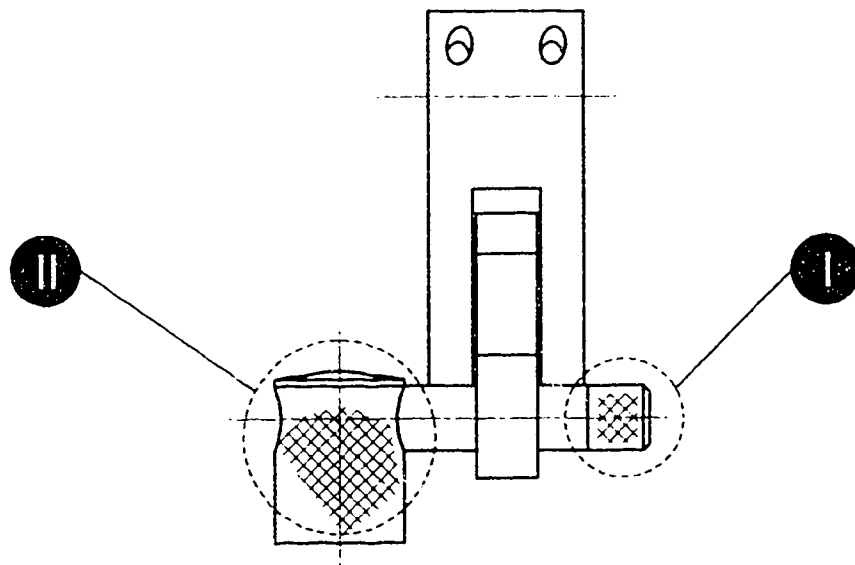
KMK01709

Driving pin and sliding piece
Visual inspection, area II

If one of the two situations outlined above is encountered, the assembly is to be renewed. The variable-fulcrum lever is likewise to be assessed.

The assembly need not be renewed if the surface is slightly shiny but not scored.

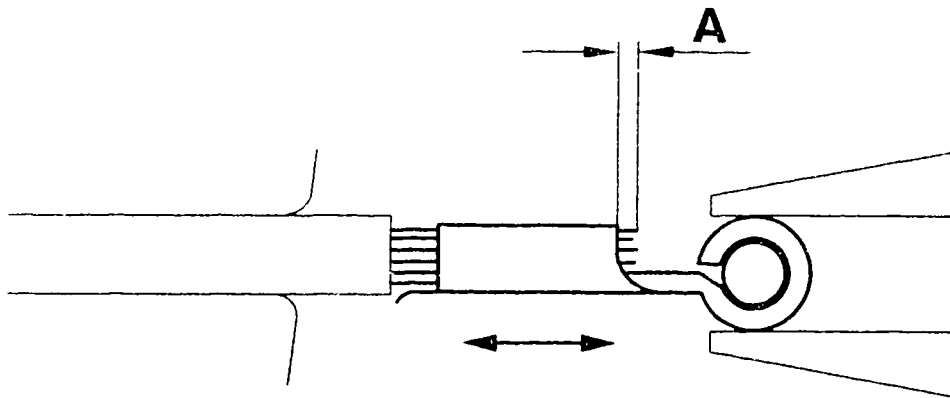
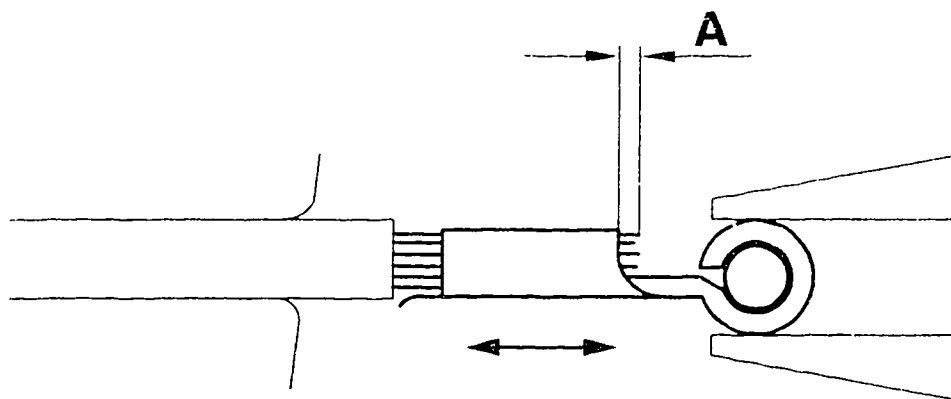
KMK04056

- * There should be no change in the length of the protruding end of the stranded wire (dimension A, see picture) on moving the lead.
- * The crimp is defective if there is even minimal relative movement between end of stranded wire and crimp.

If a crimp is loose the appropriate component (control-rod-travel or engine-speed sensor) is to be replaced. Pay attention to the detailed specifications in the repair and testing instructions VDT-W-400/019.

Note: All positioners from the start of series production up to date of manufacture 266 and no. 158 may be affected by faulty crimps. Proper ex-works crimping is ensured with newer positioners.

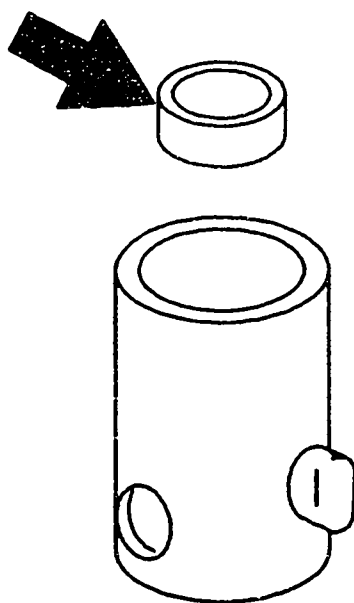
KMK02600

If it becomes necessary to replace roller tappet assembly 2 418 750 022 because of a broken pressure plate (see illustration), you must replace all 6 with part number 2 418 750 041. After doing so, we remind you to check plunger LPC and phasing.

The exchange of the roller tappet assemblies is to be performed only in the event of breakage. Standard warranty terms apply.
